San Diego, CA
NOISE-CON 2019
2019 August 26-28

Experiences with Gym Noise and Vibration in Mixed-Use Buildings

Diego Hernandez
Felipe Tavera
Ethan C. Salter, PE, LEED® AP
130 Sutter Street
Charles M. Salter Associates, Inc.
San Francisco, CA 94104
diego.hernandez@cmsalter.com
felipe.tavera@cmsalter.com
ethan.salter@cmsalter.com

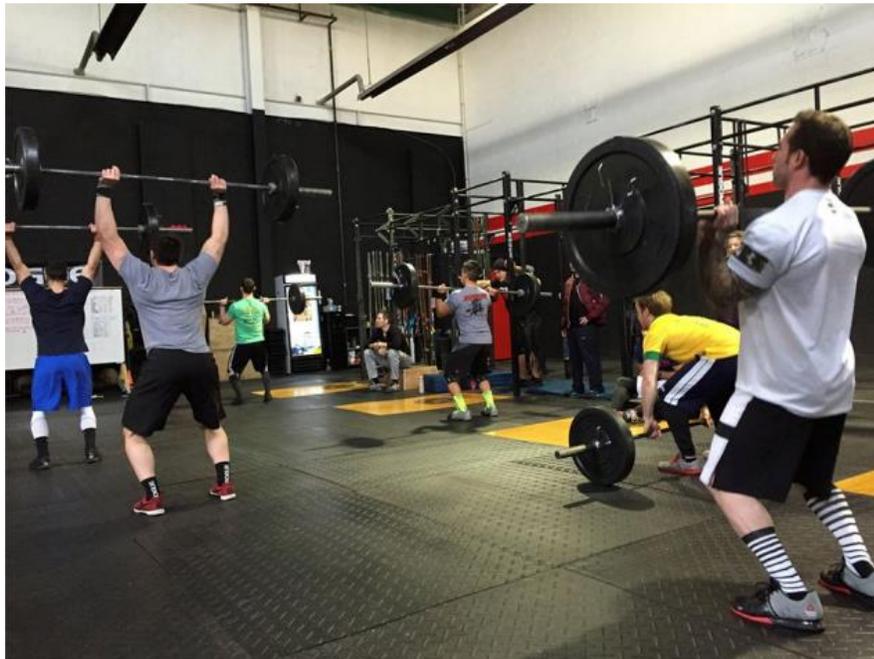
Figure 1: A typical workout at a modern gym (Flickr). Dropped weights create high impact noise in the building.

Fitness activities can generate complaints from nearby residents who are disturbed by several sources, including structure-borne noise due to weights being dropped on the floor, people jumping, and high sound levels from amplified music. The resulting intrusions are not exclusive to residents; other adjacent commercial spaces can be affected as well.

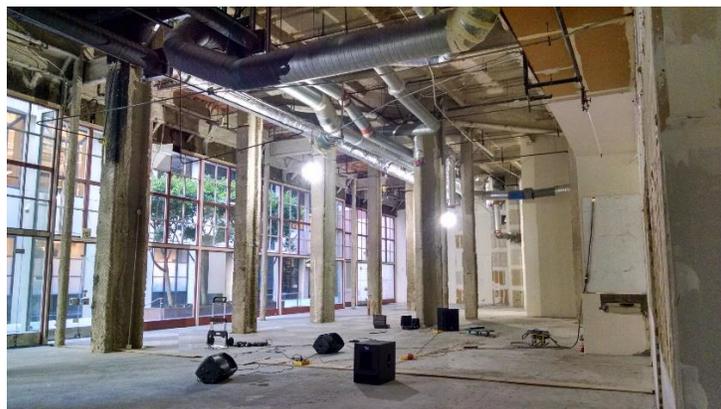
Figure 2: Mock-up of airborne noise transmission in a proposed gym facility under offices. NOISE-CON 2019, San Diego, California, August 26-28, 2019.

To determine what type of constructions will be needed, mock-ups can be built and tested in the field to determine the acoustical performance of the current assemblies. This establishes a better understanding of the building and the impact of the proposed activities (e.g., simulating gym noise, weight drops, treadmills use) at noise-sensitive spaces can be quantified.

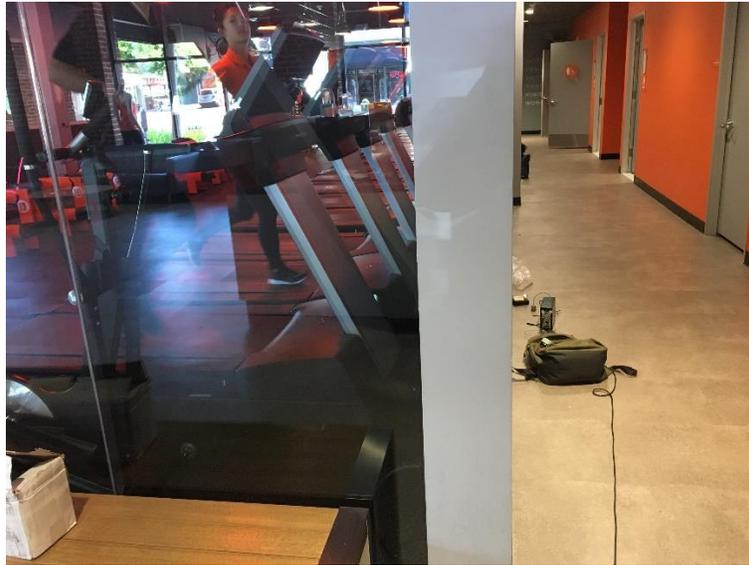
Figure 3: Vibration measurement location at the gym adjacent to rows of treadmills.

We provided acoustical recommendations for a gym in San Mateo that was already operational and had office tenants located above who were complaining of noise and vibration transfer into their space due to treadmill use. We visited the project site during typical business hours and conducted simultaneous vibration measurements in the corridor adjacent to the treadmills (fifteen treadmills in total) and on the office floor above.

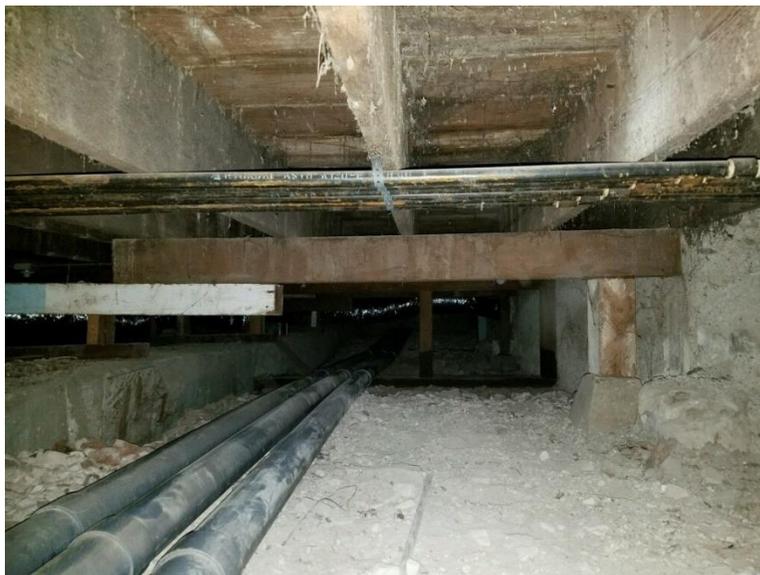
While the gym was located on the first floor, the floor assembly consisted of wood framing with a crawl space located under the area of the gym.

Figure 4: Floor assembly of the gym.

Due to the floor assembly, the treadmills imparted significant energy into the building structure. The rhythmic impact on the treadmill generated significant vibration and structure-borne noise in the conference space above. Noise and vibration also increased as the speed and intensity of the activity increased (i.e., from walking to running pace).

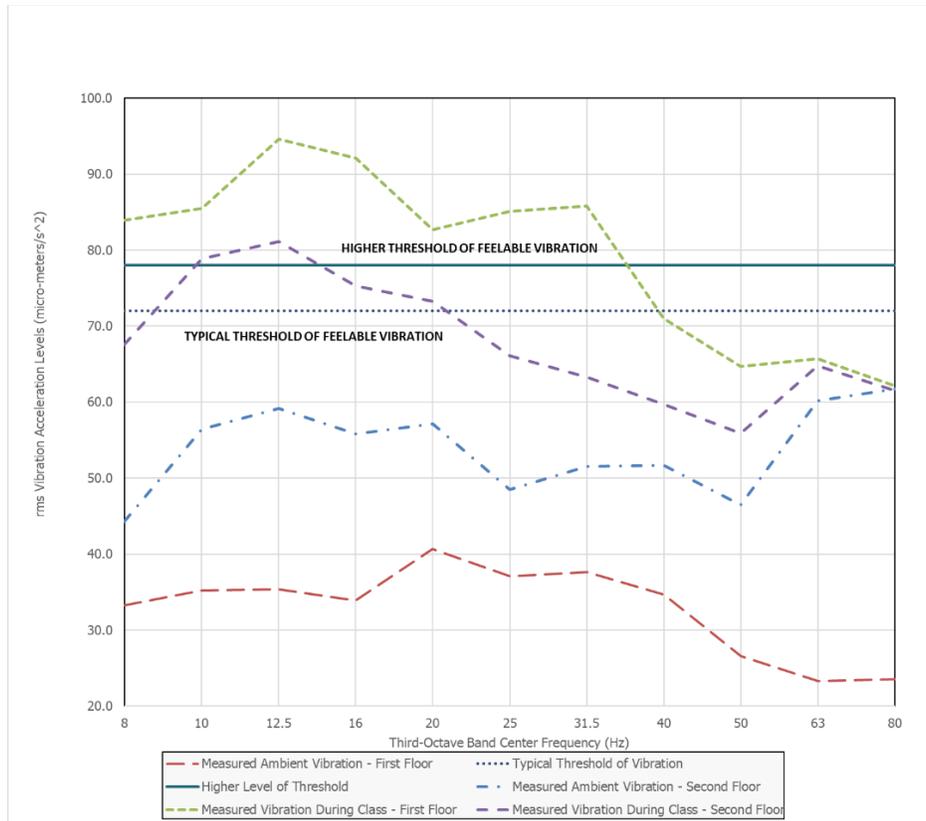
Figure 5: Measured vibration levels.

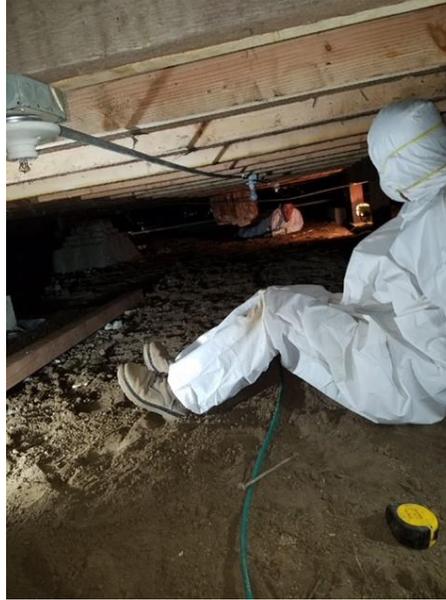
The gym owner hired a structural engineer and contractor to stiffen the floor assembly by adding beams that ran the span of the floor to the structure underneath the treadmills.

Figure 6: Structural improvements done at the gym.

After the floor was stiffened, the gym owner still felt high levels of vibration as did the office tenants upstairs. When we returned to test the assembly, we did not find any change to the previous vibration levels, which was inconsistent with our previous experiences. We set up a meeting with the structural engineer on-site to review the assembly and found that the new structural supports were not installed properly. The new beams had a gap below the structure which did not provide any additional support.

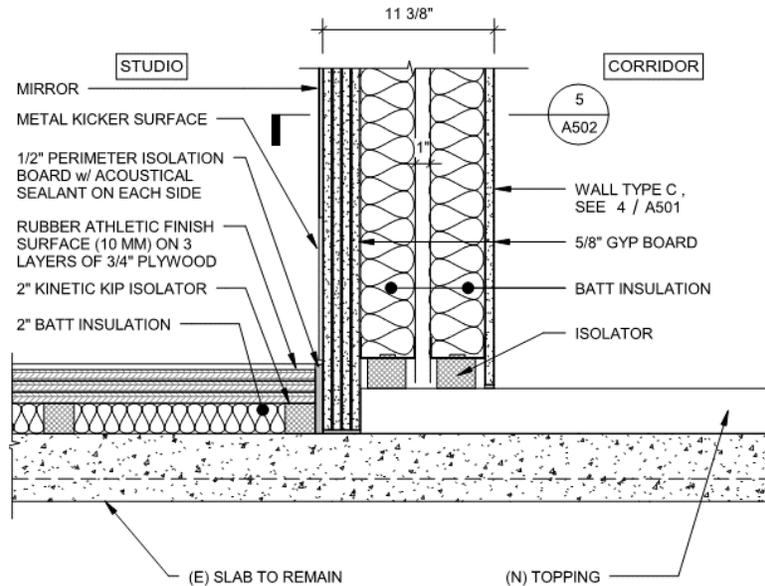
Figure 7: The designed assembly as shown in the project drawings.

We provided acoustical recommendations for a gym in San Francisco that offers a high-intensity group workout regimen using treadmills, free weights, and other exercises, all led by an instructor shouting into an amplified sound system. We conducted a mock-up study for this project and determined that an isolated floating floor assembly would be required to reduce free-weight impact noise transmission to adjacent noise-sensitive receivers. During design of the project, we worked with the architect to design an assembly that would meet the project goals.

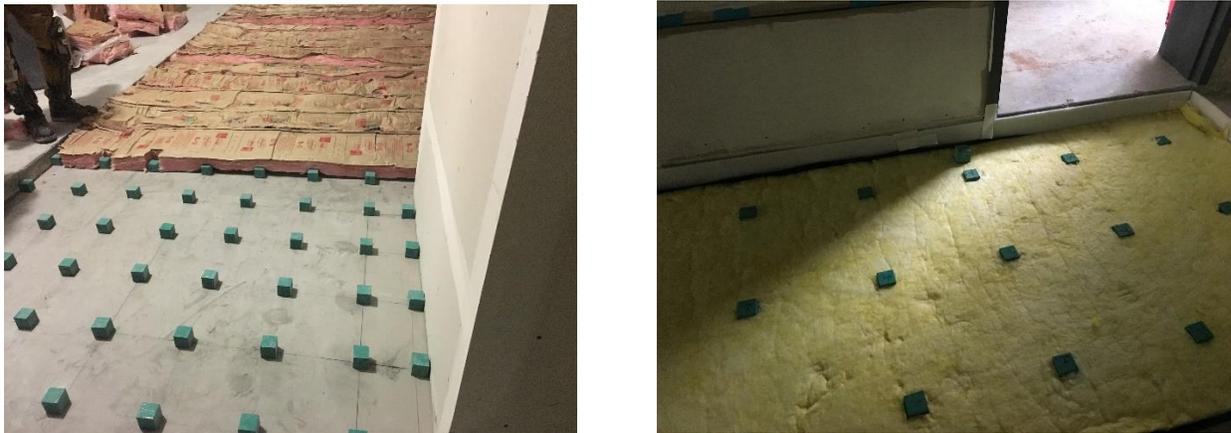
Figure 8: The installed floor (left) compared to specified product (right).

While the isolators were the same, the product specified (i.e., Kinetics RIM system) comes with the insulation incorporated between the glass fiber isolators. The isolators were not installed in the direction where they are effective (in compression). Additionally, the installed assembly did not incorporate the required 1/2-inch thick perimeter isolation board. The installed floor was not acceptable for numerous of reasons:

1. Without any shop drawings, no calculations had been conducted to address static load, and the isolators could have been incorrectly selected to account for the needed deflection.
2. The isolators are tested under compression for their performance. With the specified Kinetics RIM system, the mat system rolls out so that each isolator is facing the correct direction for compression. The individual isolators were installed in different directions, which could result in acoustical and structural defects of the floor.

3. The insulation installed was the wrong thickness and was preventing contact between the plywood and the isolator. Additionally, the insulation was to have been unfaced. The contractor was cutting custom holes in standard, faced building insulation.
4. Without the perimeter insulation board, the floor would have had a rigid connection with the rest of the structure, which would have “short-circuited” the isolators.

After much deliberation with the subcontractor, we learned that the installed product had been ordered from a different vendor representative of the manufacturer without a submittal review or engineered shop drawings. The installed floor was not acceptable and had to be removed, which led to a delay in schedule and additional cost for materials and labor.

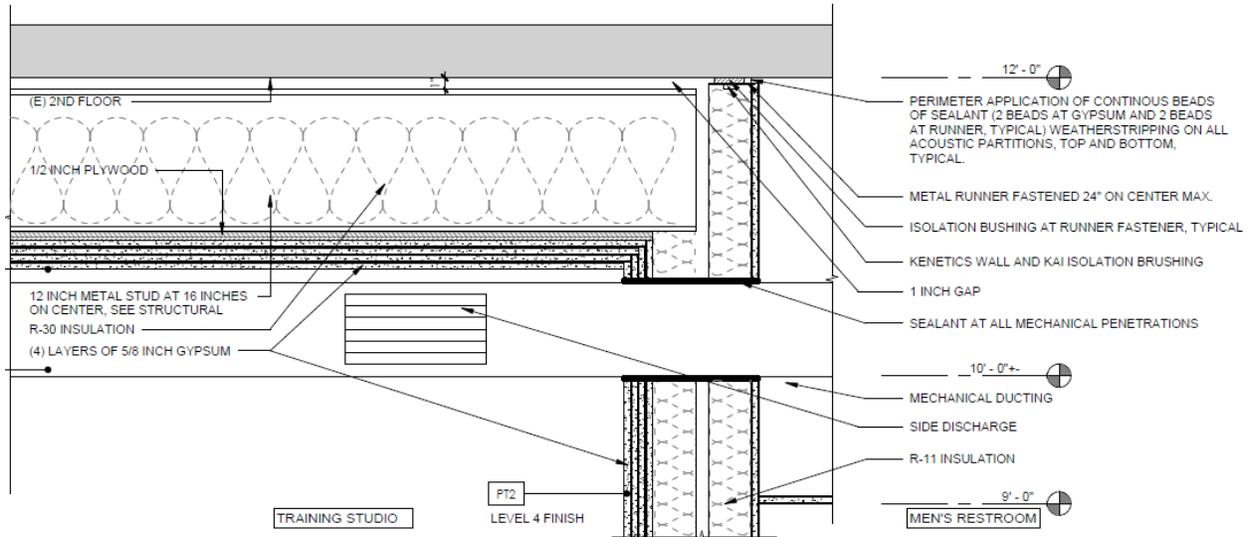
Figure 9: The designed ceiling assembly as shown in the project drawings.

We provided acoustical recommendations for a new gym in San Francisco that also offers a high intensity group workout regimen using treadmills, free weights, and other exercises, led by an instructor. From our understanding, the ceiling assembly separating the studio from an upstairs real estate office was composed of a six-inch thick concrete slab. However, after we conducted a mockup study for this project, we found the assembly lacking in performance, only achieving an NIC (Noise Insulation Class) rating of 30. Based on the lower performance of the assembly, we provided recommendations for a ceiling assembly with a “tunnel” ceiling construction and stricter maximum allowable sound pressure levels in the studio.

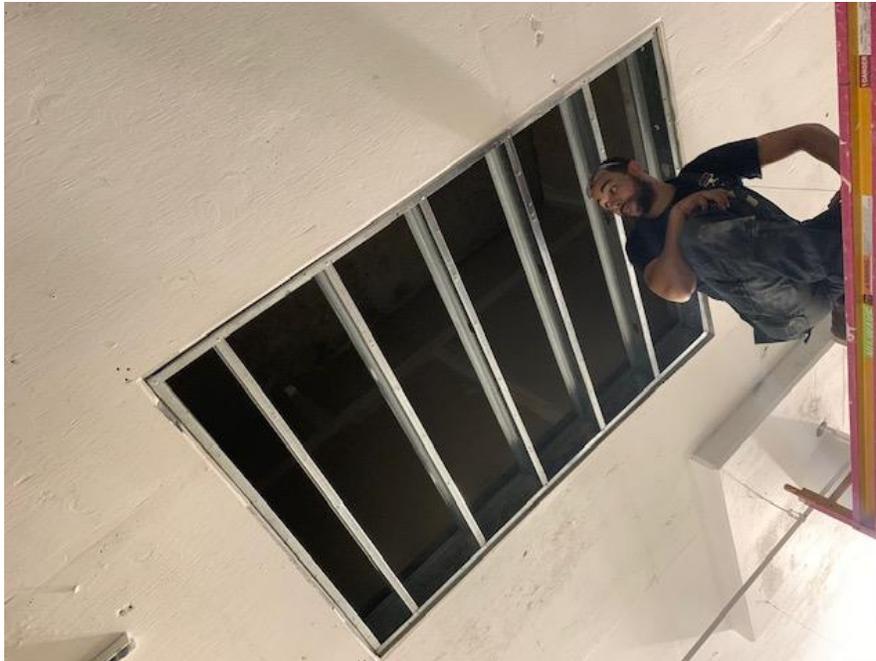
When construction began and the contractor removed the existing gypsum board in the studio, the crew found an existing infill of the slab that was just plywood (approximately five feet by seven feet) with no concrete above.

Figure 10: The “framed” infill in the slab of the studio.

We had recommended that the hole be filled with concrete from the top, but that was not possible due to constructability limitations and there being a tenant above. Therefore, the hole had to be filled from below with an assembly comprising eleven layers of one-inch-thick cement board, which had an equivalent surface density as the concrete slab. This assembly was sealed airtight at its perimeter.
